**UNDERWATER REMOTE SENSING AND TERRESTRIAL SURVEY
PENSACOLA BAY AND DEADMAN'S ISLAND
SANTA ROSA COUNTY, FLORIDA**

FINAL REPORT

APRIL 2003

**Panamerican Consultants, Inc.
15 South Idlewild Street
Memphis, Tennessee 38104
Contract No. DACA01-02-P-0472**

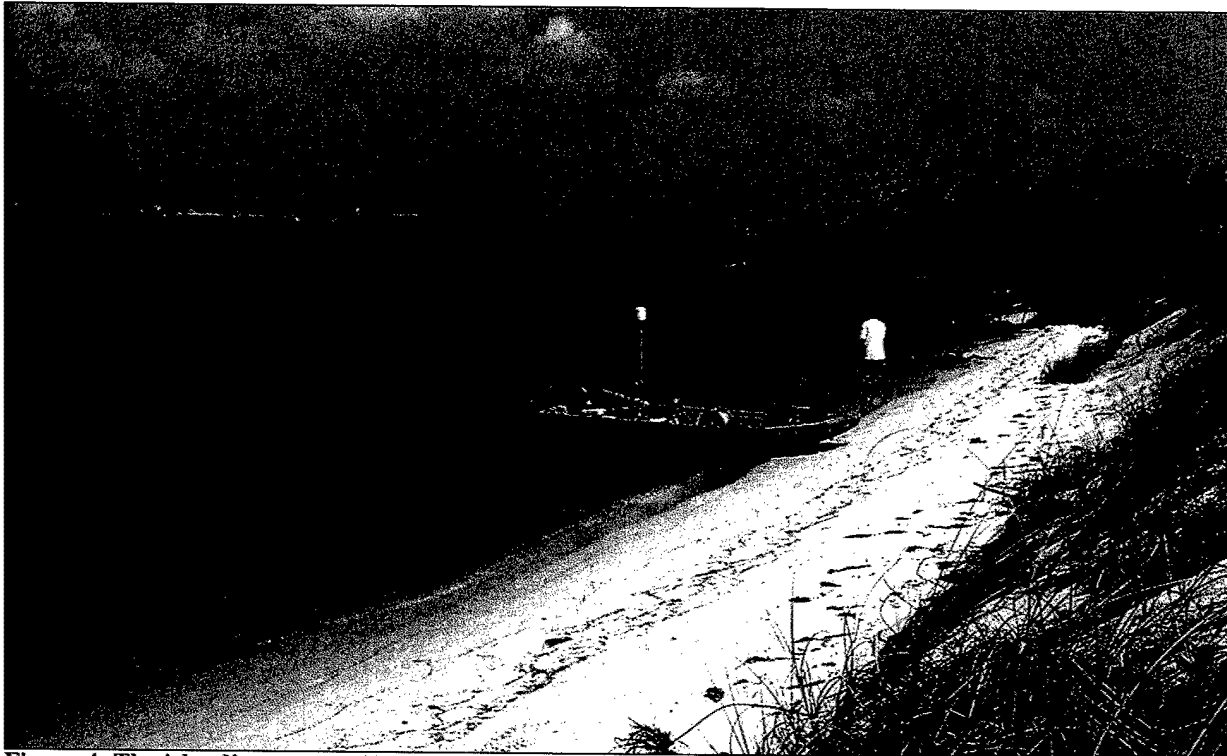
Figure 4. The island's western side is a steeply sloping dune face that shows clear signs of continuing erosion. Note the trees eroding along the shoreline in the distance. Project area's southern terminus is adjacent to the boat. View is to the north.

As illustrated in Figure 4, the island's western side is a steeply sloping dune face that shows clear signs of continuing erosion. Atop the four to five foot high dune, the land is level for some distance but gradually slopes towards the edge of Gilmore's Bayou that is fringed by marsh saw grass (*Serenoa repens*). On the northern tip is found the highest ground, still no more than six feet above mean sea level. It slopes quickly to the east where it blends into the two-foot high and approximately 10 foot wide sand spit that connects the island to the bluff. The vegetation on the island is characteristic of the Florida Gulf Coast dune community. Located on the face and top of the dune, the sea oat zone is the first vegetation zone adjacent the bay water, being able to withstand salt spray and little fresh water. As one proceeds inland, the sea oats (*Uniola paniculata*) are replaced by a scrub and forest zone comprised of stunted live oak (*Quercus virginiana*), and various scrub vegetation that survive in a climate of little water, harsh sunlight, salt spray, and strong winds.
